Service Bulletin 181001 Rev A

Hot Water Drain Plug Missing Screw

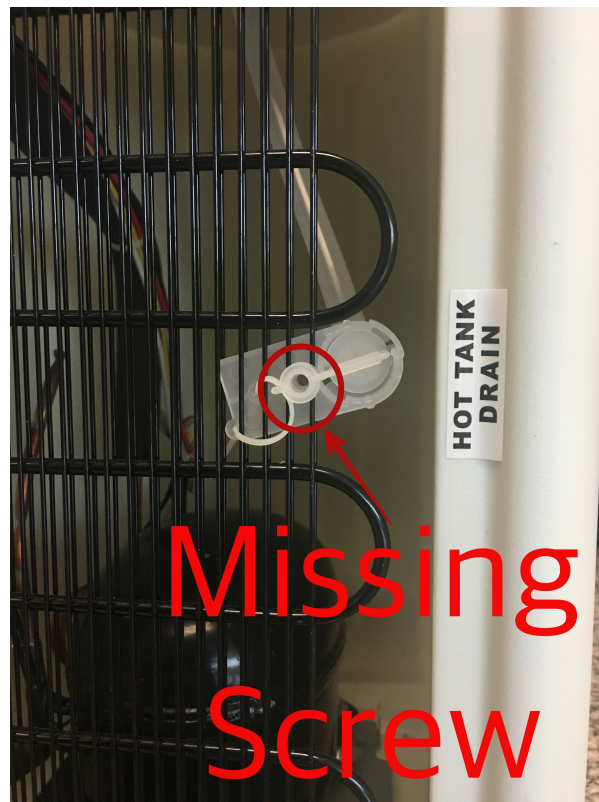
The hot water drain plug in the rear of MTN and AquaCafe dispensers may be missing the locking screw. This is a critical safety issue.

Either during the manufacturing process or when MTN and AquaCafe dispensers are serviced the locking screw may not be properly installed or reinstalled.

During any service call or installation of a new unit, verify the drain and the vent (if two plastic outlets) on the rear of the dispenser each have a locking screw inserted.

This prevents any accidental release of hot water. If either screw is missing use a #10 x 3/4" Sheet Metal screw or equivalent to secure the drain or vent plugs.
